WEBINAR MAINTENANCE SERIES

ADVANCE ANALYSIS OF VIBRATION MONITORING

CASE STUDY

Dilakukan pengambilan data vibrasi pada turbin uap sebelum dilakukan overhaul.

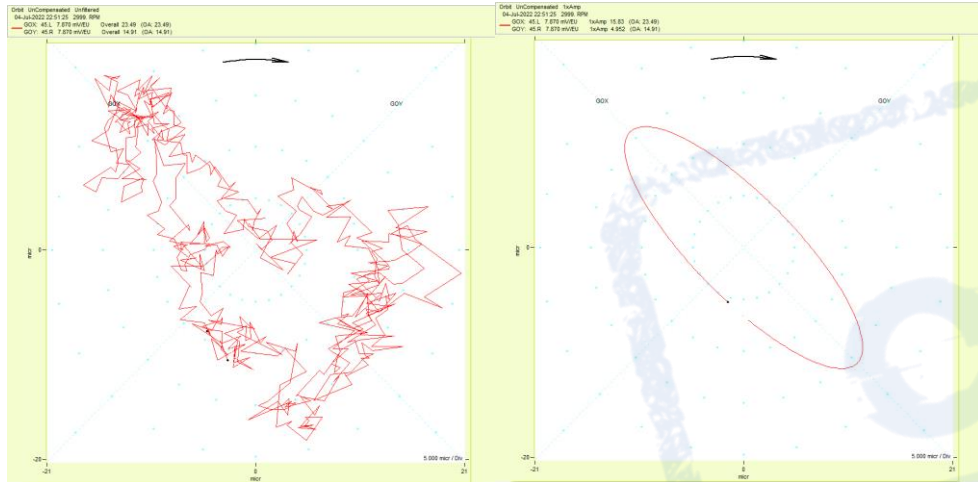
On turbine inboard bearing, unfiltered orbit plot shows erratic pattern with an elliptical shaped orbit at 1X vibration. This might indicate a preload condition on the turbine shaft, which can be caused by misalignment.

- Balancing (metode: trim run, splitting weight, four run balanced method, dll)
- Re-alignment (metode: straight edge/feeler gauge, Using laser MA, Dial indicator)
- Lakukan CLIT

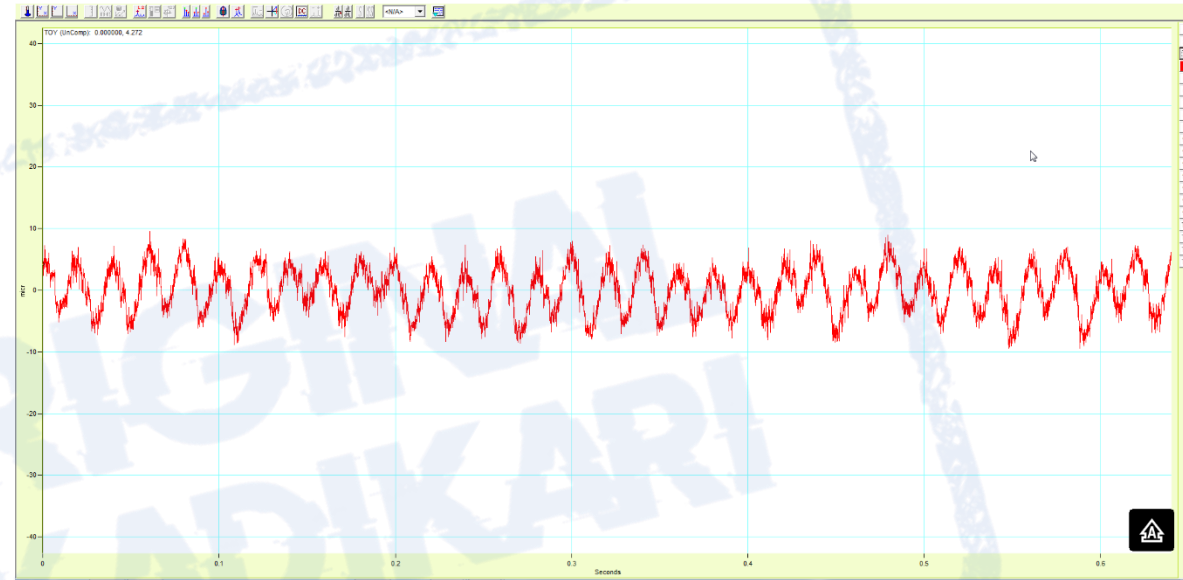
The time waveform turbine section shows a sinusoidal graph and will show a harmonic spectrum, in the generator section an impact phenomenon begins to appear but there is no modulation which indicates the absence of sidebands in the spectrum. In general, the possibility that we can observe through this time waveform is a bearing problem. We will need supporting analysis to verify this possibility.

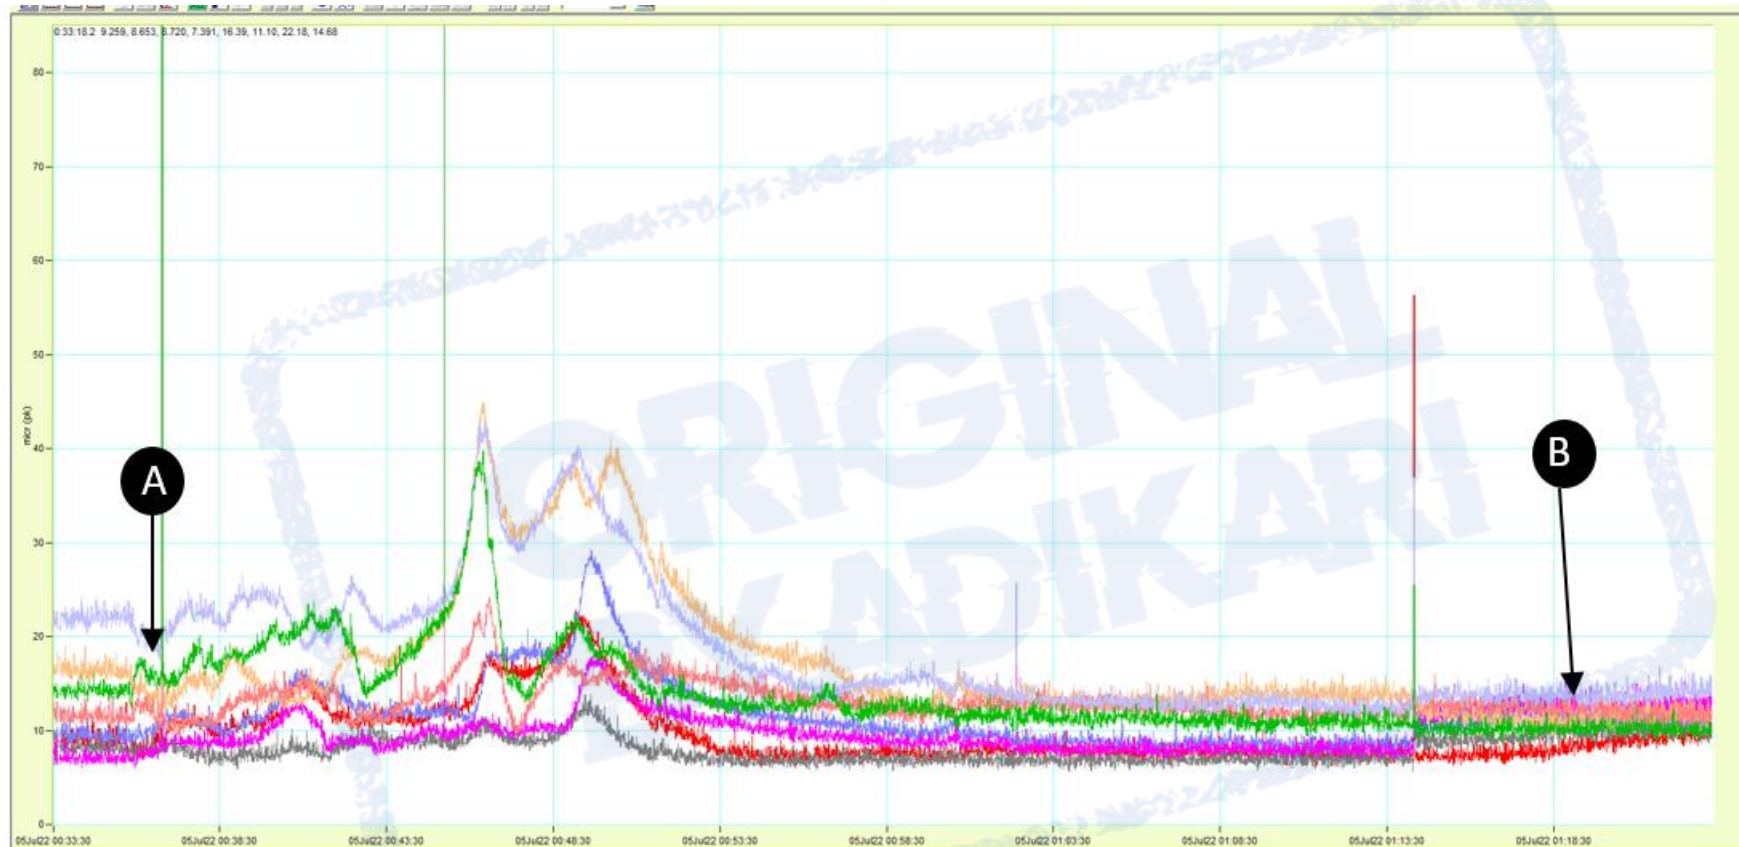
The coast down process starts from the unit with a load of 53MW until the unit stops at 0 RPM and no load. This process is divided into several conditions, namely when the load starts to be reduced from 53MW at the point before (A), after that the unit is in the FSNL condition at point (A). The FSNL condition of the rotating speed starts to approach 0 RPM (B).

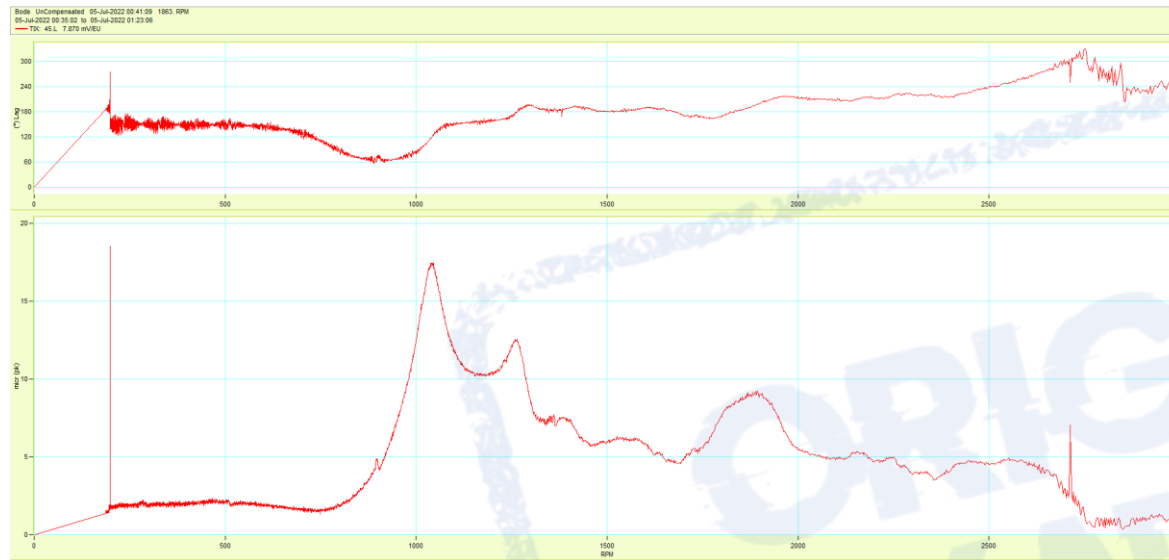
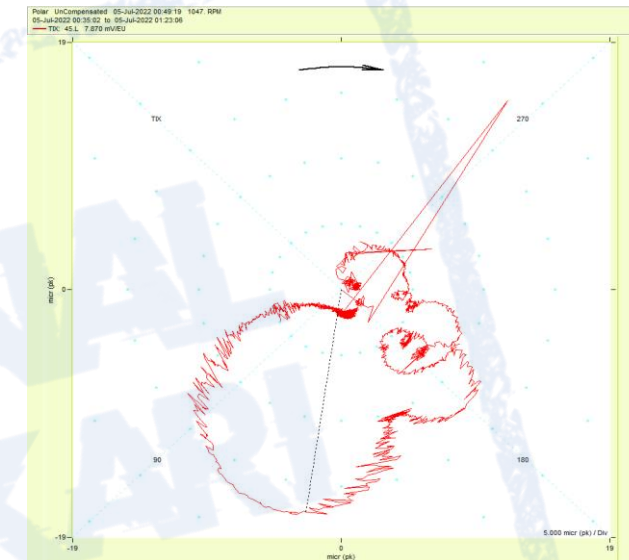
From the bode plot, it can be seen that the critical speed in the turbine section (Turbine Inboard and Outboard) occurs at around 1020 RPM @ 204 deg and 1896 RPM @ 194 deg.

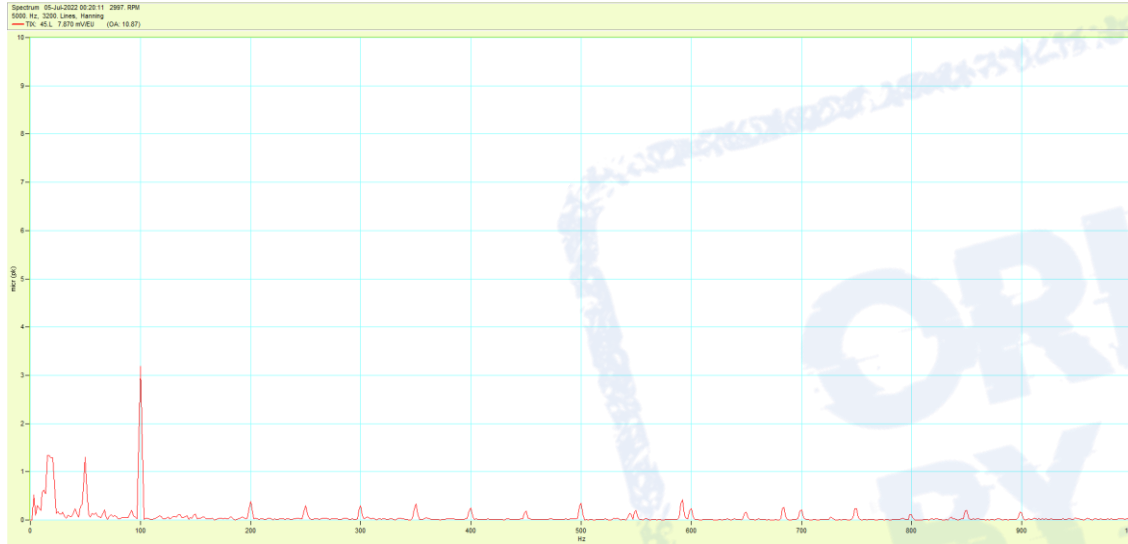
All data capture points show a 1X (50 Hz) harmonic spectrum. This spectrum may indicate loose in housing bearing, 1X peak and moderate at 2X indicates misalignment caused by soft foot. Misalignment caused by the soft foot will usually cause angular misalignment.

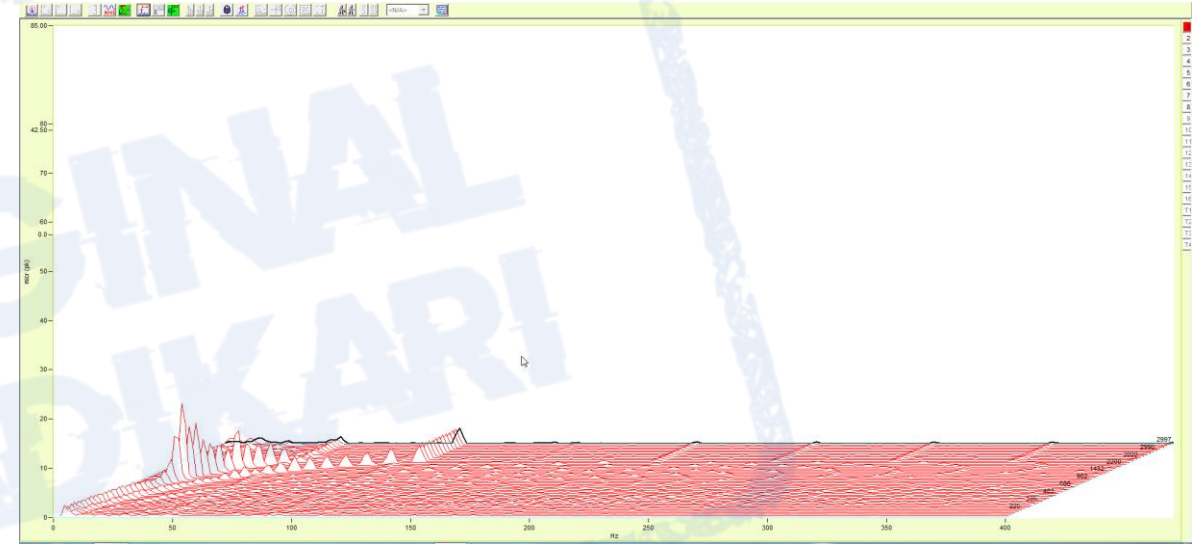
The waterfall plot on both turbine bearings are dominated by 1X and 2X peaks. During coast-down, there is a significant increase in amplitude of 1X peak when the turbine passes its critical speed at 1020 RPM, which then subsides afterwards.

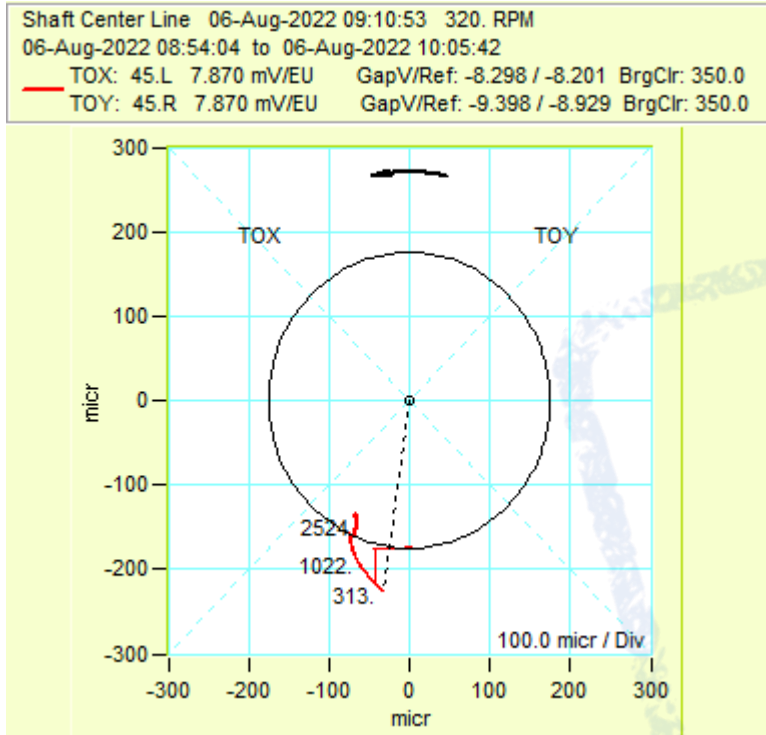
On all four bearings it is shown that the shaft centerline were pressing against the bottom limit of the bearing clearance. This could indicate a possible sign of misalignment. It could also be caused by gap voltage reference error which was taken during slow roll process instead of during standstill. Considering low overall vibration level on all four bearings, it is still within normal condition.
